DAVID EVANS
AND ASSOCIATES INC.

September 2, 2009

SUBJECT: COURTHOUSE SQUARE QUARTERLY BUILDING-MONITORING PROGRAM

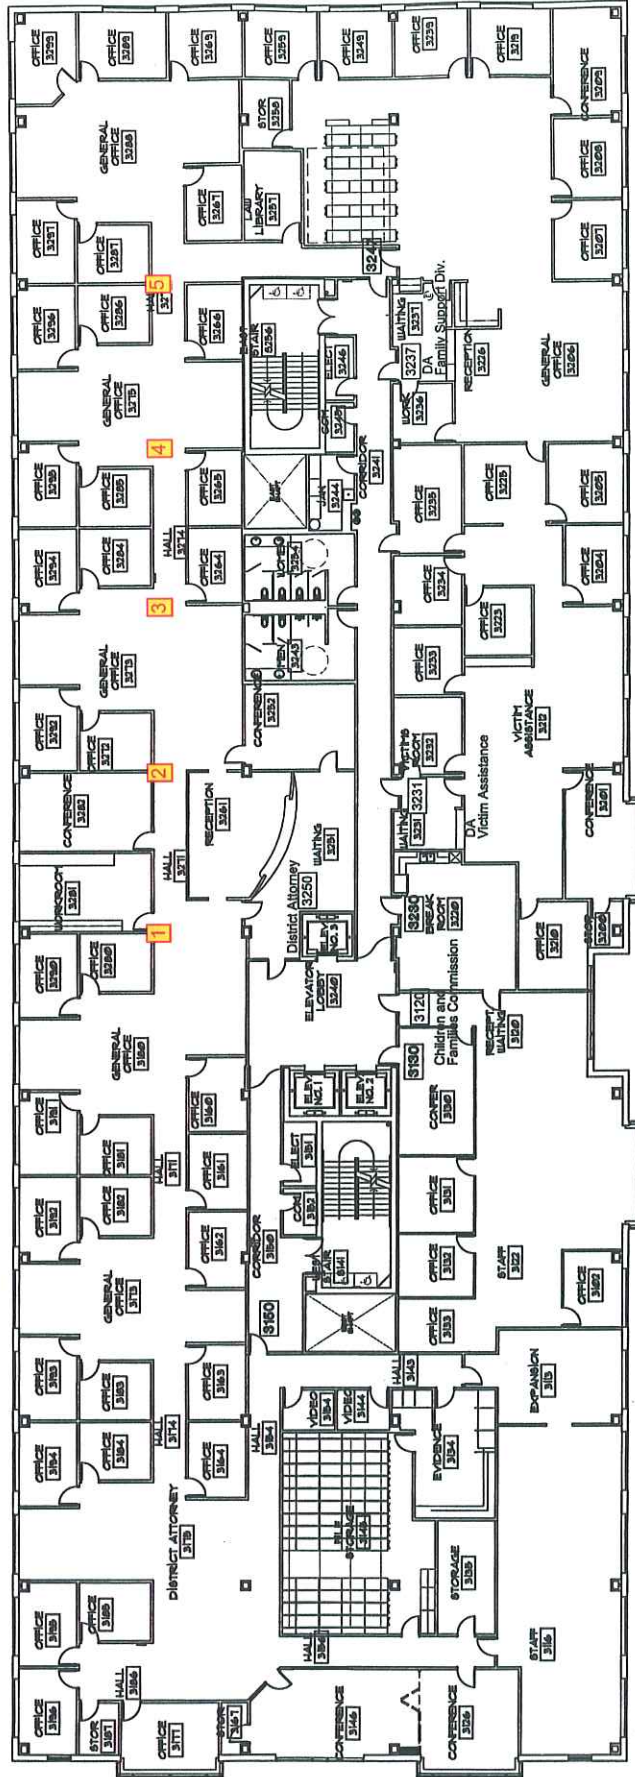
CS-3

3rd Floor Location	Nov. 24, 08 Deflection (in.)	Aug. 31, 09 Deflection (in.)	Δ Deflection (in.)
1	1.3	1.4	0.1
2	1.9	2.1	0.2
3	1.4	2.1	0.7
4	2.8	2.4	-0.4
5	2.1	2.1	0

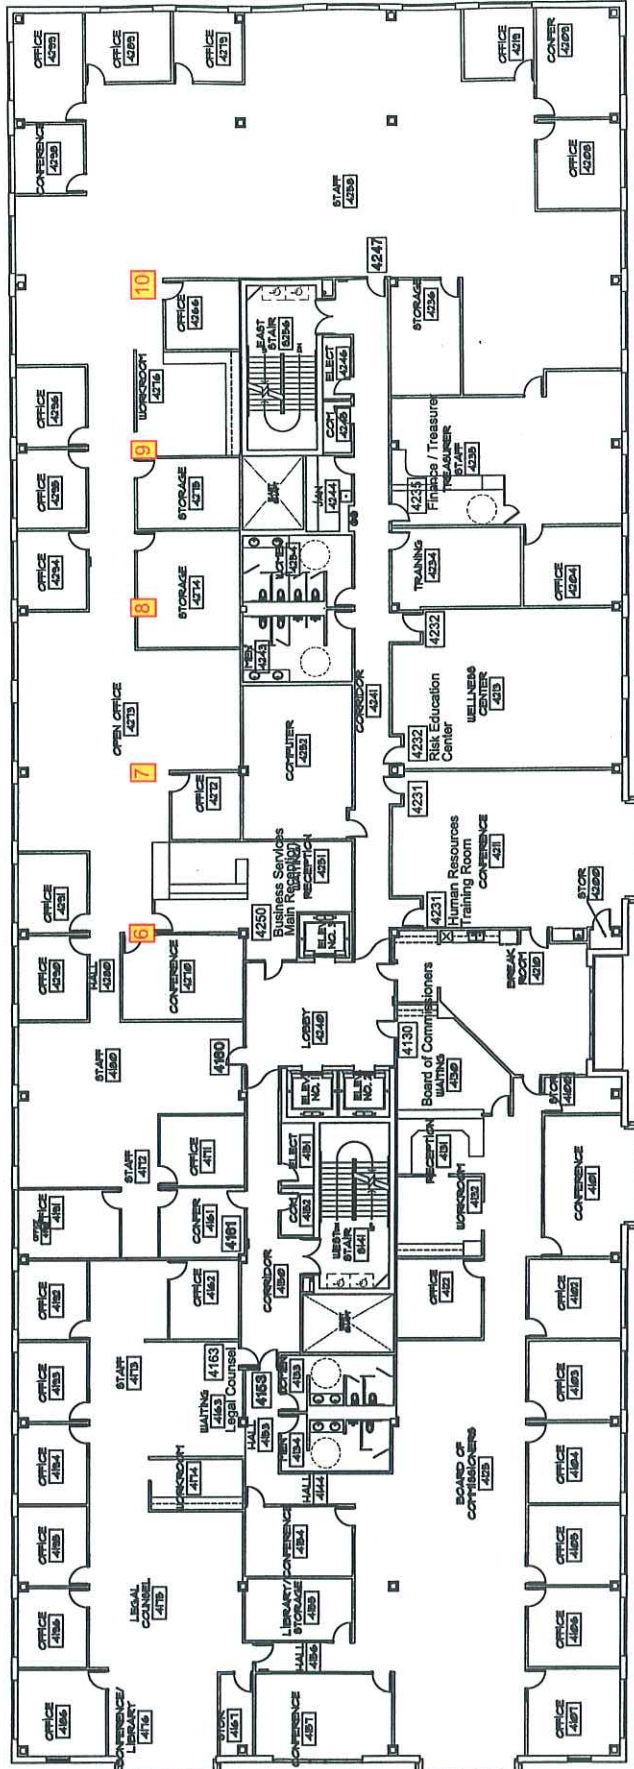
CS-4

4th Floor Location	Nov. 24, 08 Deflection (in.)	Aug. 31, 09 Deflection (in.)	Δ Deflection (in.)
6	1.3	1.2	-0.1
7	1.4	1.3	-0.1
8	1.5	1.7	0.2
9	2.2	2.2	0
10	2	1.5	-0.5

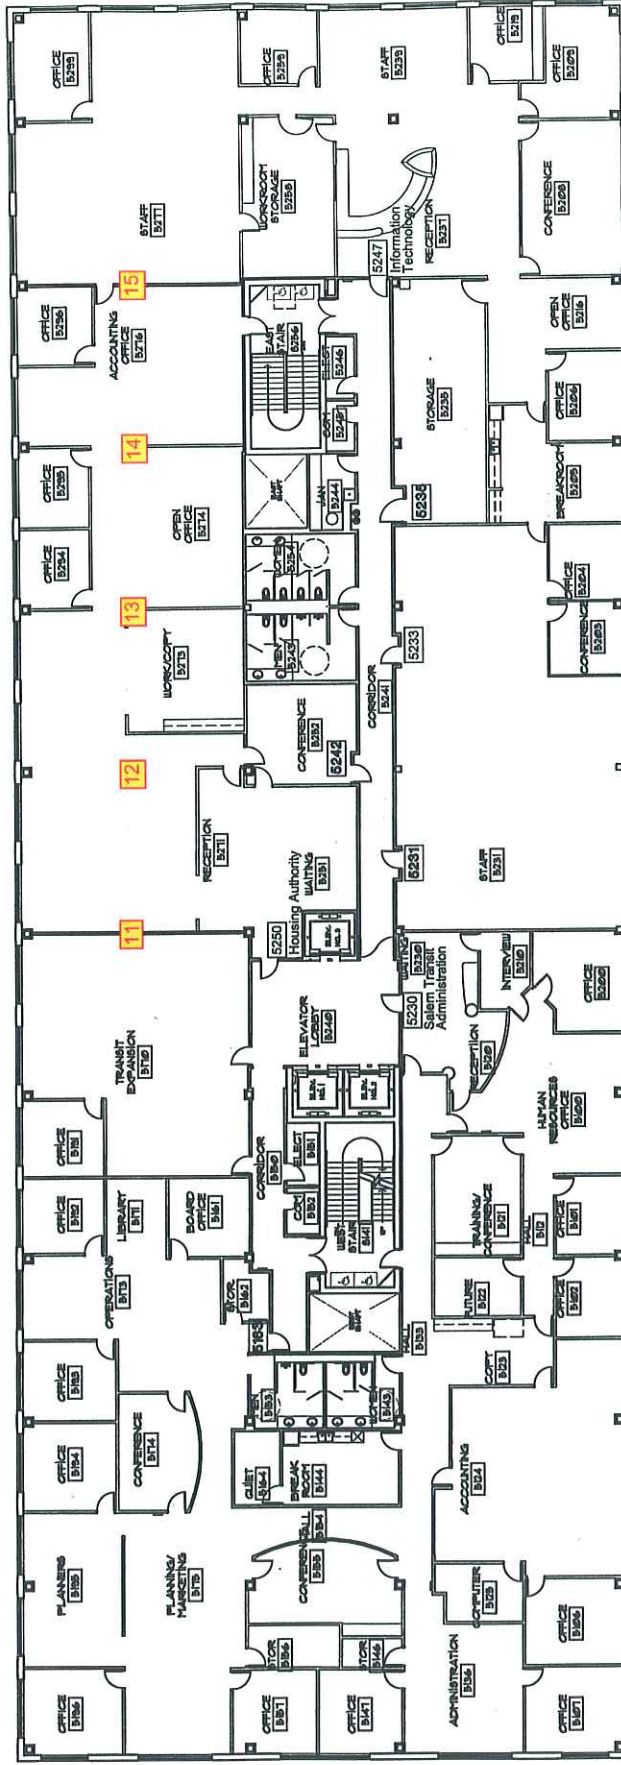
CS-5

5th Floor Location	Nov. 24, 08 Deflection (in.)	Aug. 31, 09 Deflection (in.)	Δ Deflection (in.)
11	1.9	2	0.1
12	2.2	2.3	0.1
13	1.7	2.2	0.5
14	3.2	3.5	0.3
15	2.9	2.5	-0.4
